Technical Service Bulletin:

Potential Missing Charge Compensator

Models: CA009 – Rev C Water Source Heat Pump

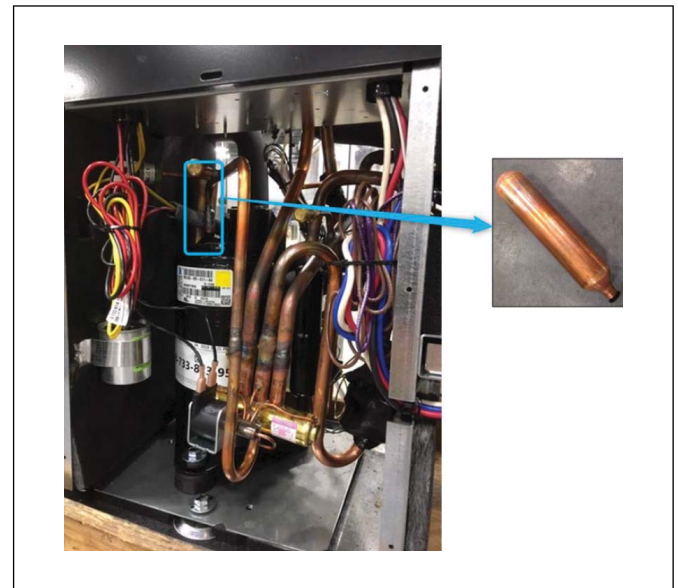
Figure 1

The affected units had an incorrect TXV valve installed, and the charge compensator component was left out of the unit.

Examine the internal components to see if the charge compensator is installed (see fig.1 below):

- ▶ If the charge compensator is present; The product was assembled correctly and no further action is required.
- ▶ If the charge compensator is missing; This is an affected product.

If the affected product is a model that has a **Copper** coaxial heat exchanger installed, then the solution is to simply reduce the refrigerant charge from 28oz down to 20oz. No other action needs to be taken.

Unfortunately, affected CA009 products that contain a **Cupro-Nickel** coaxial heat exchanger must be replaced, as there is no field fix available. Please initiate a warranty replacement claim with reference to "RMA70000706".
