# Product Information Notice

Models: GB142-24,30,45,60

Subject: GB142 Gas Supply Pipe Update

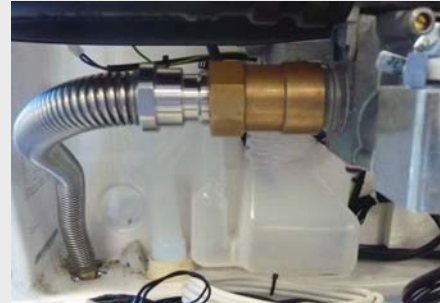
Figure 1

GB142 boilers manufactured between 2004 and 2008 were shipped with a corrugated stainless steel gas supply pipe (Figure 1). Moisture from re-circulating flue gas or leakage from the heat exchanger air vent can potentially damage the stainless steel supply pipe and may lead to pin hole corrosion and the potential for gas leakage.

In 2008 the gas pipe (p/n 76685) was redesigned to include a protective rubberized sleeve which provides additional protection against corrosion (Figure 2). This part is available as a free upgrade and the older unprotected gas pipes should be replaced during normal maintenance of the GB142 boiler.

For a replacement gas supply pipe, please contact customer service with model, serial number, and homeowner information at 1-866-642-3198.
