Product Information Notice

Models: SSB255, SSB399, and SSB512 Boilers

Subject: Condensate Collector – Identifying Potential Cracks

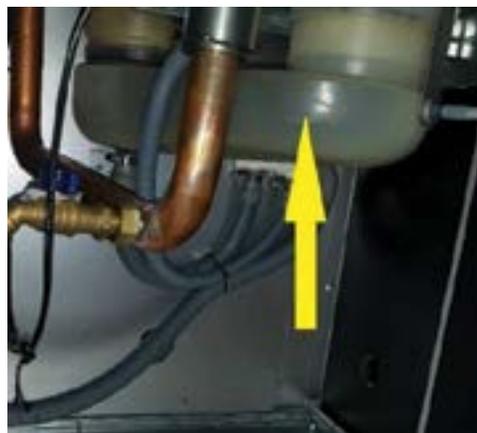
Figure 1

A2: The condensate collector is found at the bottom of the boiler, located below the cylindrical heat exchanger (see fig.1 below):

A3: Corrosion or discoloration of the sheet metal below the condensate collector.
Drips, or pools of moisture on the sheet metal below the condensate collector.
Streaks of discoloration or liquid running down the condensate collector.

1. Turn off the boiler's power supply.
2. Turn off the gas supply to the boiler.
3. Remove the condensate collector from the boiler.
4. Inspect the condensate collector to ensure that no cracks or other damage are evident. Pay particular attention to the large openings at each end that connect to the exhaust pipe and the bottom of the heat exchanger.
5. If no damage is evident, reinstall the condensate collector into the boiler. Ensure that all connections are made.
6. If damage is found to the condensate collector, it must be replaced. Bosch will provide a replacement at no charge up to 5 years from date of installation through the standard online warranty process.
7. If you have any questions regarding the information provided in this document, please contact the Bosch Technical Support Department by phone at 1-800-283-3787, or via email at boiler.techsupport@us.bosch.com
