Technical Service Bulletin:

Cracked Flue Pipe – Overview & Resolution

Models: Bosch SSB255, SSB399, and SSB512 Boilers

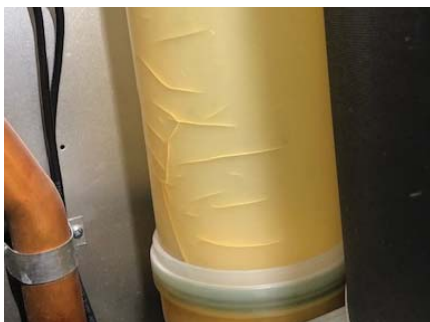
Figure 1

At the next service visit, visually inspect the polypropylene flue pipe along the length to look for discoloration, and also for the appearance of cracks (see Figures 1 and 2 for examples).

If cracks or discoloration are found in the existing polypropylene flue pipe, replace it with the appropriate stainless steel flue pipe available from Bosch. Please refer to the table below for replacement part numbers:
