Technical Service Bulletin Repair of Flue Gas Leakages

Summary

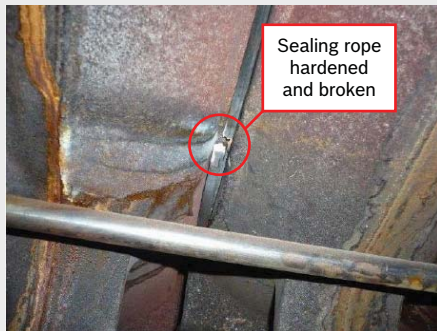
Figure 1

Flue gas leakages between cast iron sections or flue gas headers (see Fig. 1 & 2) can occur for the following reasons:

- ▶ Maintenance not performed as required
- ▶ Incorrect control adjustments or constant high boiler temperatures (175-205°F)
- ▶ Incorrect burner selection
- ▶ Incorrect burner adjustments (over firing)
- ▶ Incorrect chimney draft
- ▶ Incorrect air intake draft

Correct the problem by sealing the leakage between sections with a high pressure sealing compound. Complete the steps below using the following material:

1. Disassemble the housing and identify where the flue gas leakages are occurring.
2. Clear away the old sealing cord and debris.
3. Ensure the section on the boiler to be sealed is clean, dry and free of grease and rust.
4. The sealant should be applied using a Caulk Gun to ensure a consistent sealant bead.
5. Apply the sealant around the entire outside of the cast iron boiler section.
6. The sealant bead should have a width of approx. 5/8" and should be 1/4" deep.
7. With the sealant applied at the specified dimensions, smooth out the sealant bead with your finger for even distribution and correct sealing.
