Technical Service Bulletin Repair of Flue Gas Leakages

Summary

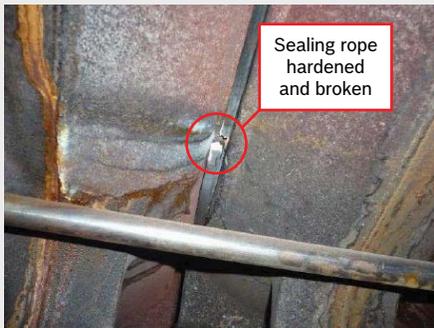
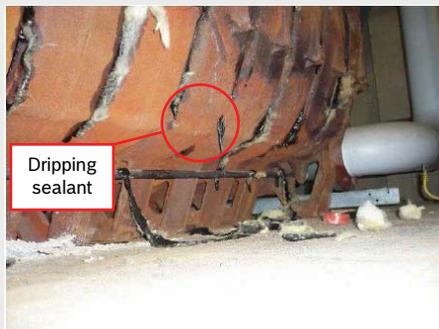
Figure 1

Flue gas leakages between cast iron sections or flue gas headers (see Fig. 1 & 2) can occur for the following reasons:

- ▶ Maintenance not performed as required
- ▶ Incorrect control adjustments or constant high boiler temperatures (175-205°F)
- ▶ Incorrect burner selection
- ▶ Incorrect burner adjustments (over firing)
- ▶ Incorrect chimney draft
- ▶ Incorrect air intake draft

Correct the problem by sealing the leakage between sections with a high pressure sealing compound. Complete the steps below using the following material:

1. Disassemble the housing and identify where the flue gas leakages are occurring.
2. Clear away the old sealing cord and debris.
3. Ensure the section on the boiler to be sealed is clean, dry and free of grease and rust.
4. In a properly vented area, apply primer using a brush on the sealing groove between the sections. (width of approx. 1.25")
5. Allow 30 minutes for the primer to dry before high pressure sealing compound can be applied.
6. The sealant should be applied using a Caulk Gun to ensure a consistent sealant bead.
7. Apply the sealant around the entire outside of the cast iron boiler section.
8. The sealant bead should have a width of approx. 5/8" and should be 1/4" deep.
9. With the sealant applied at the specified dimensions, smooth out the sealant bead with your finger for even distribution and correct sealing.
