Technical Service Bulletin:

Excessive Condensation

Models: Inverter Ducted Split Heat Pump Products

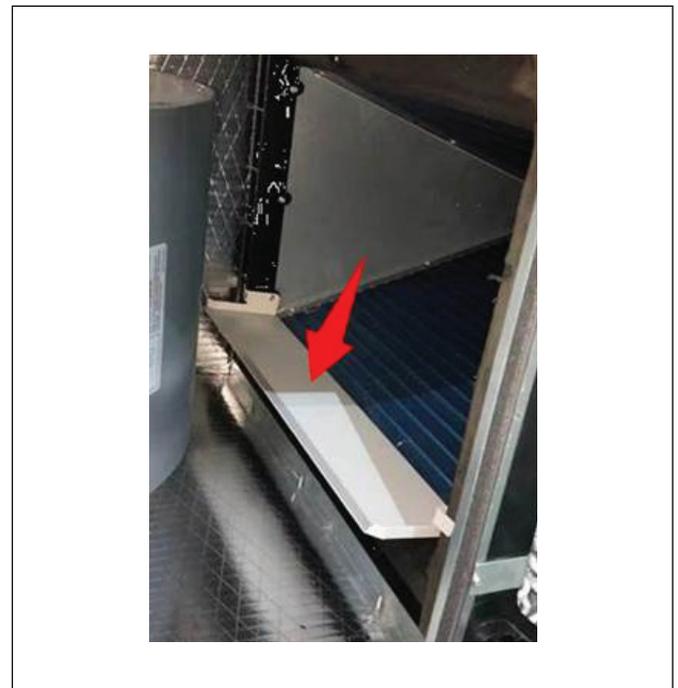
Figure 1

When installed, the lip of the new component will extend approximately 4in beyond the end of the A coil to catch the condensation and channel it back to the drip pan through the coil fins (see Fig.1).

If the previously outlined solutions are not feasible, we have made available an after-market solution that can be ordered from your distributor and installed into the product to catch the moisture via an extension lip.

Extension Drip Pan Part Number – 8733955686.
